# Glenorchy Rees Floodbank

## Floodbank Assessment

3 September 2020

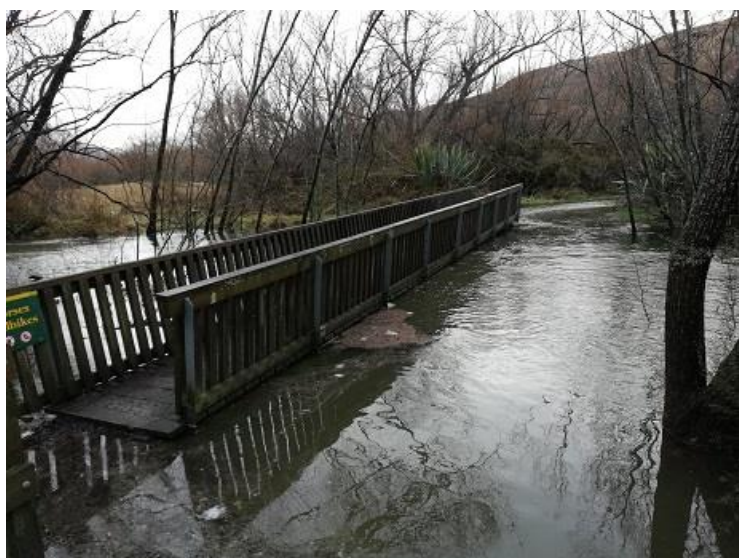
Since the initial inspection there has been a further significant rainfall which resulted in flooding of the Lagoon Creek bridge around the 21<sup>st</sup> July. This was detailed in an email from Ulrich Glaser (QLDC) showing photographs of the flooding taken by Ingrid Temple.

*Figure 1 - Lagoon Bridge 21st June. Photograph Ingrid Temple to Ulrich Glaser*

Remedial works were then undertaken by Otago Regional Council (ORC) at the end of July 2020 which involved clearance of the vegetation in the Lagoon stream and dredging of the riverbed to relocate the main Rees channel towards the true right bank.

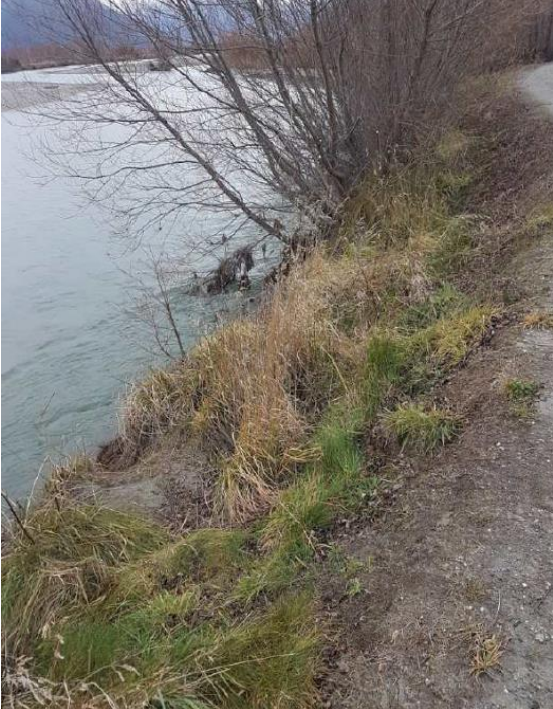
<p>Stab.3</p>	<p>Immediately downstream of the Lagoon confluence, evidence of slope failure where undercut by the Rees river, 1H:1V (45°)</p>

<p>Stab.4</p>	<p>Downstream from the Lagoon Stream confluence, evidence of slope failure where undercut by the Rees river 1H:1V (45°)</p>

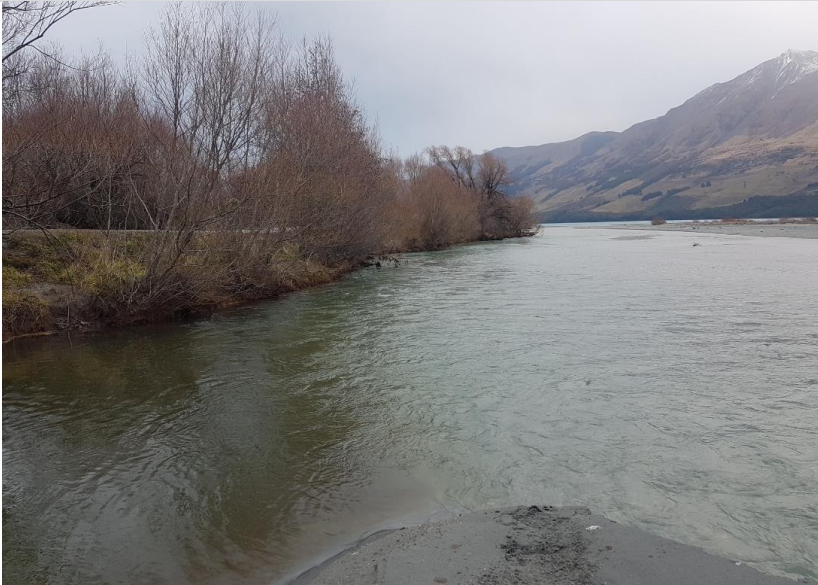
The critical areas of external erosion are considered to be the confluence of the Lagoon stream and the Rees River, and the length of stopbank where the Rees River runs up against the stopbank.

ID	Situation	Photograph
Ext.1	Section immediately downstream of Lagoon stream confluence

Preliminary rock armour design was undertaken using the methods outlined in the International Levee Handbook, according to the relationships derived by Pilarczyk suggesting that for a design flow of 2.3m/s, armour stones of approximately  $D_{50} = 1.0\text{m}$  are required at the embankment.

Typically, the armourstone is placed to a thickness of 2.5 times the characteristic stone thickness, meaning an armour stone thickness of 2.5m would be recommended.

- Installation of rock armouring to the 50m long section around of the Lagoon stream confluence. If additional funding is available, this rock armouring shout extend the full length of the stopbank downstream (approximately 300m total, additional 250m).
- Installation of groynes or river training upstream of the confluence
- Repair of oversteep areas and
- Vegetation maintenance

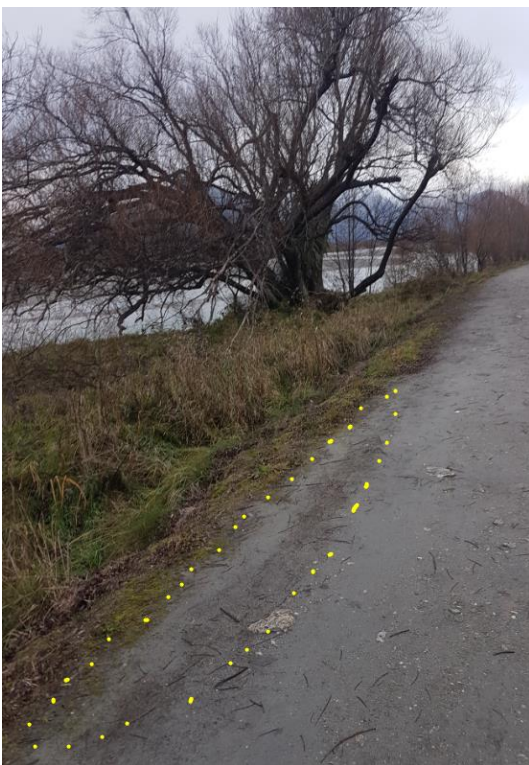
Based on the inspections completed to date key signs of a progressing failure in the embankment are considered to be associated with a reduction in the trail width, as a result of slipping of the bank. This may be manifested as:

- A localised drop in level at the edge of the track, (as seen below)
- Trees and vegetation leaning
- Buckled surface of the vegetation, indicating surface creep of the slope

*Figure 7 - Indicative surface slumping of the embankment crest*

It is therefore recommended that periodic inspections are completed to assess the potential for developing failures and enable early intervention lessening the potential for a catastrophic failure.
