# **Glenorchy flooding**

## **Update for GCA, 2<sup>nd</sup> July 2020**

# HEAD OF LAKE WAKATIPU HAZARDS STRATEGY

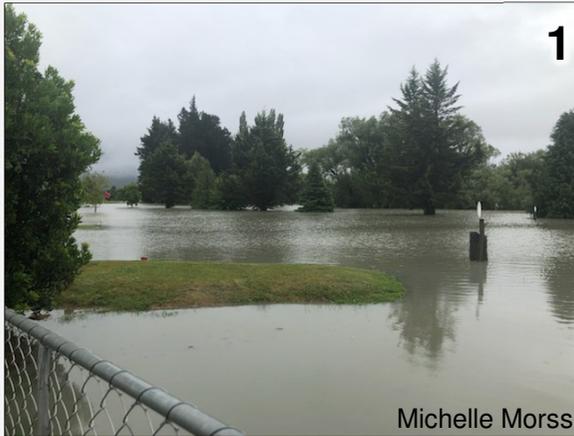
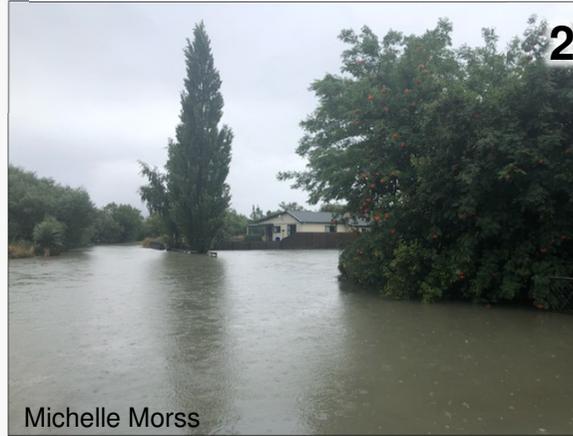
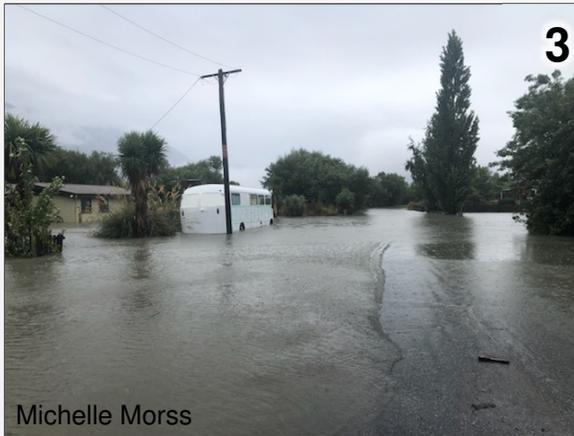
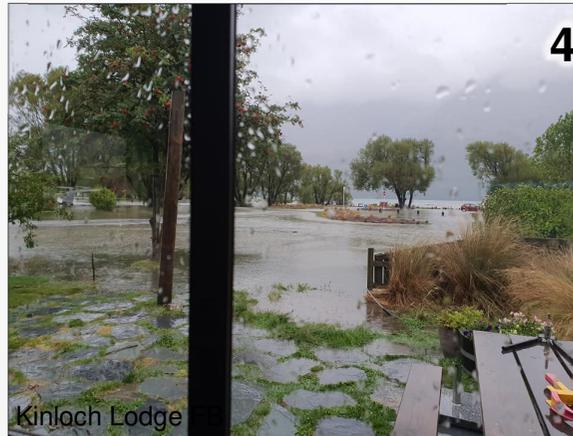
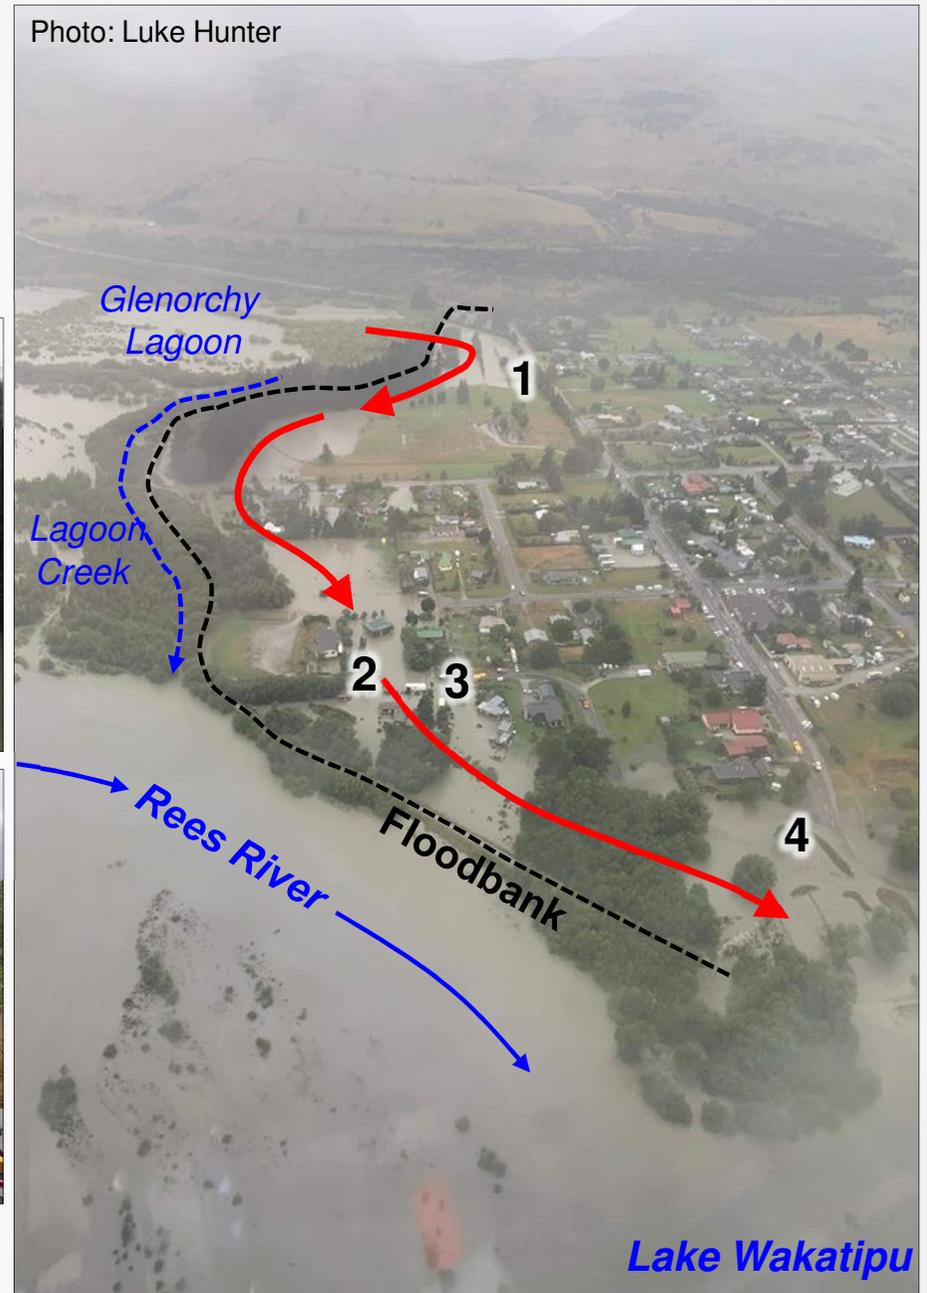
## 4<sup>th</sup> February 2020

\*Note photos are not necessarily at flood peak

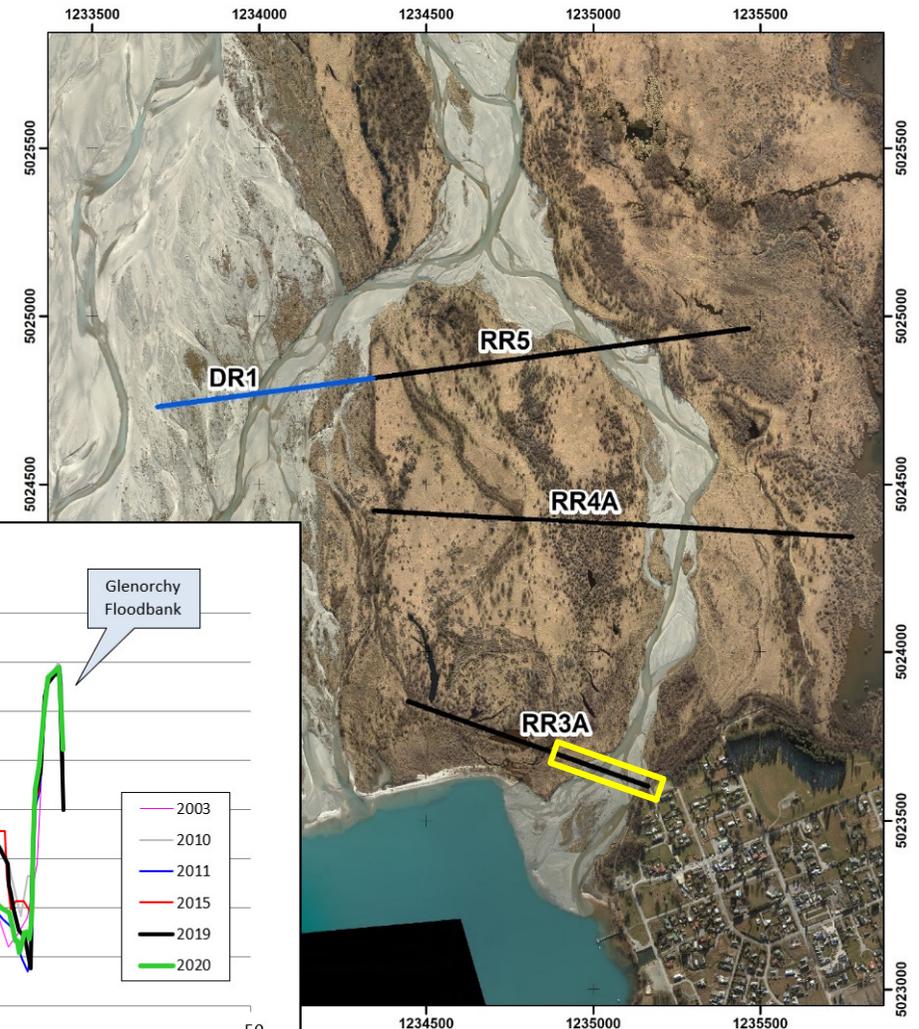
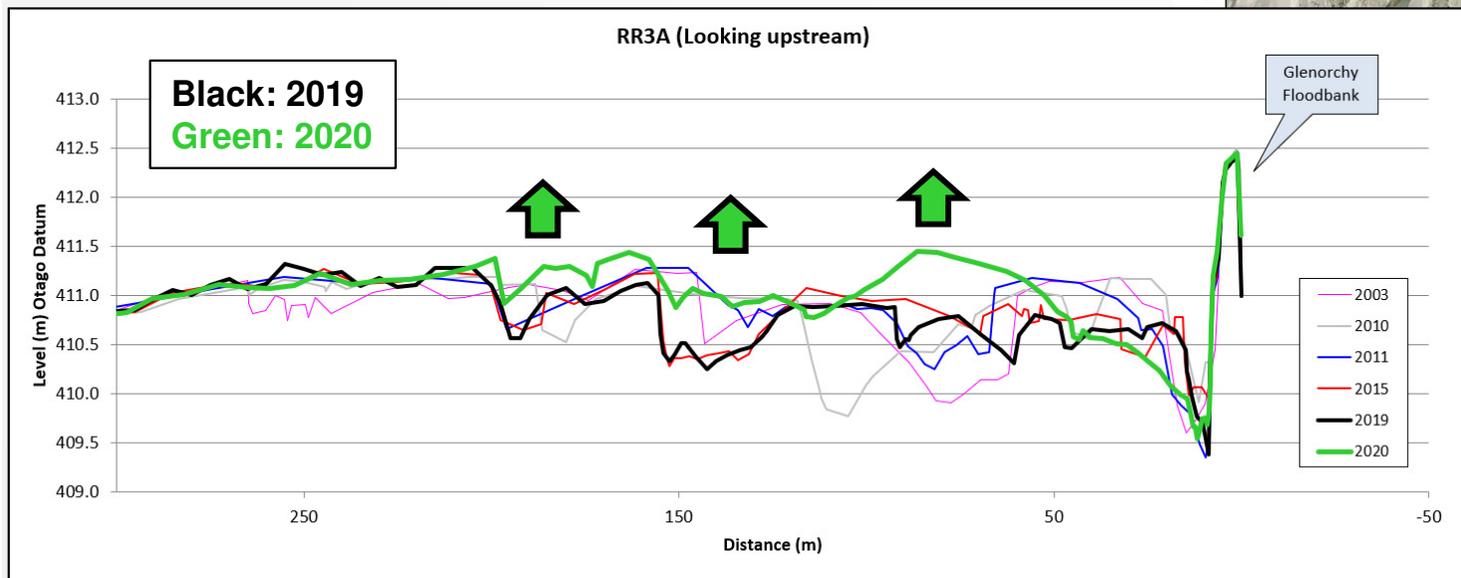
## Changes 2019-2020

- **DR1:** 35-40cm degradation
- **RR4A and RR5:** no change (still within 15cm of 2019 bed level)
- **RR3A:** 25-30cm aggradation

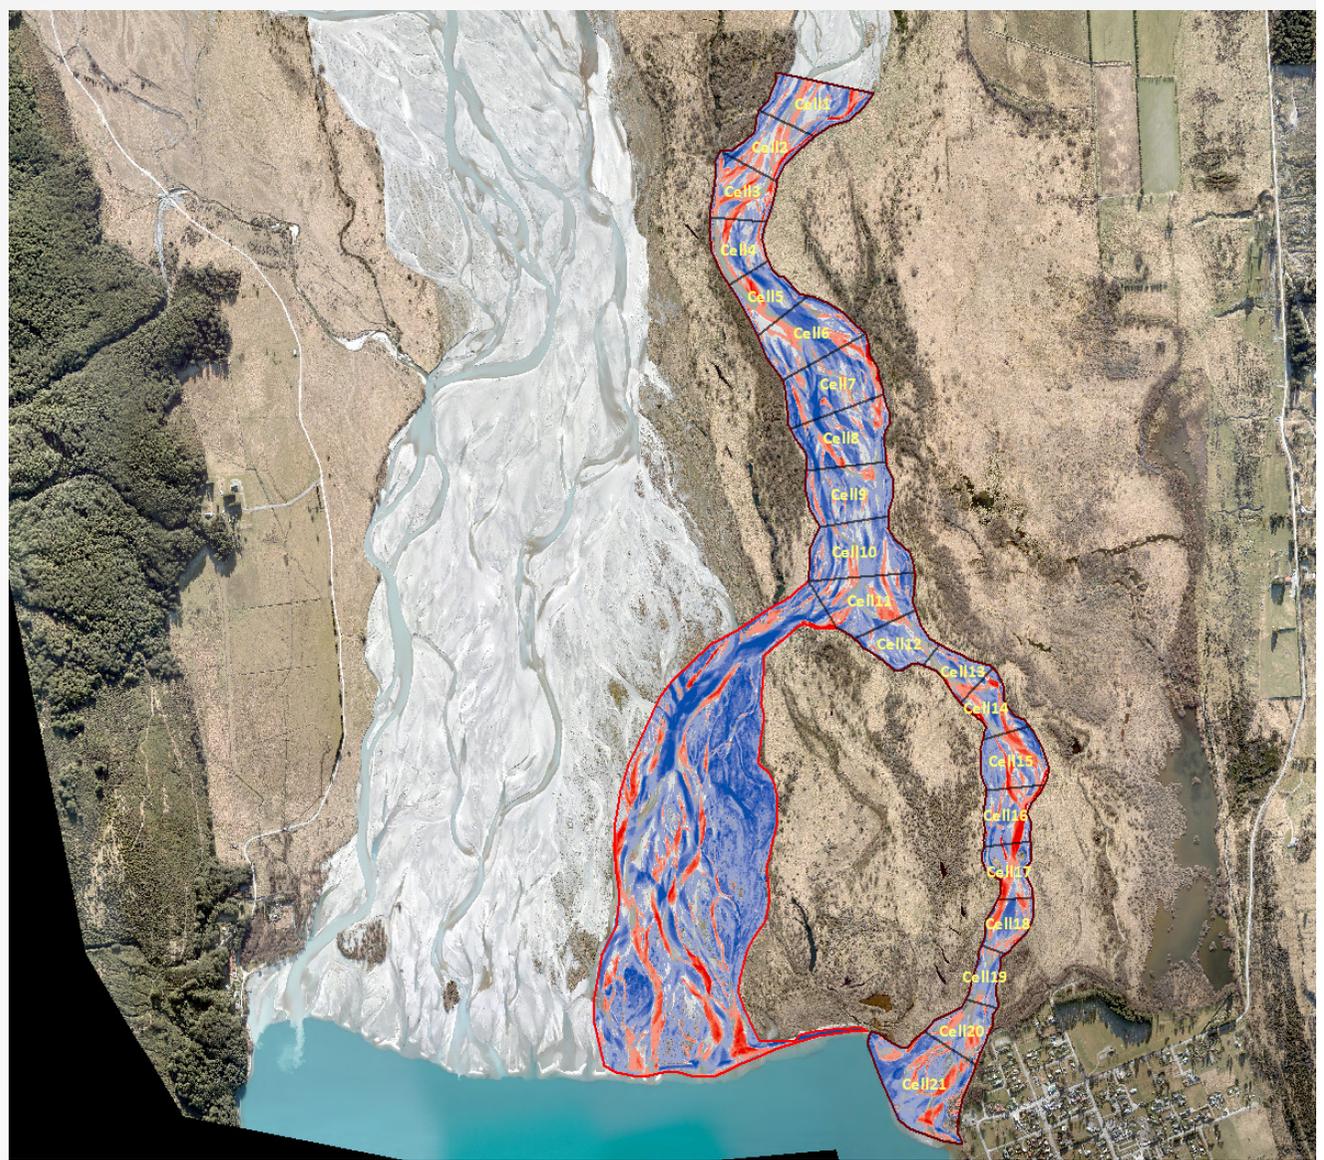
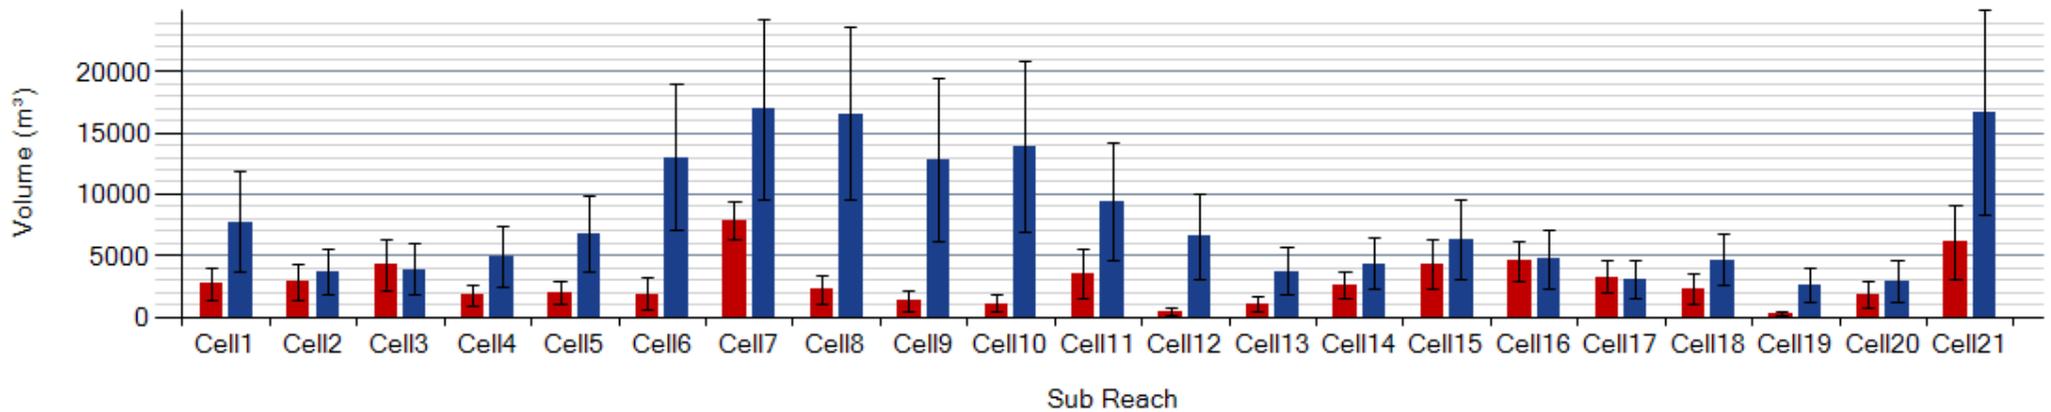
# REES RIVER BED LEVEL CHANGE – 2011-2019

Blue = sedimentation  
Red = erosion

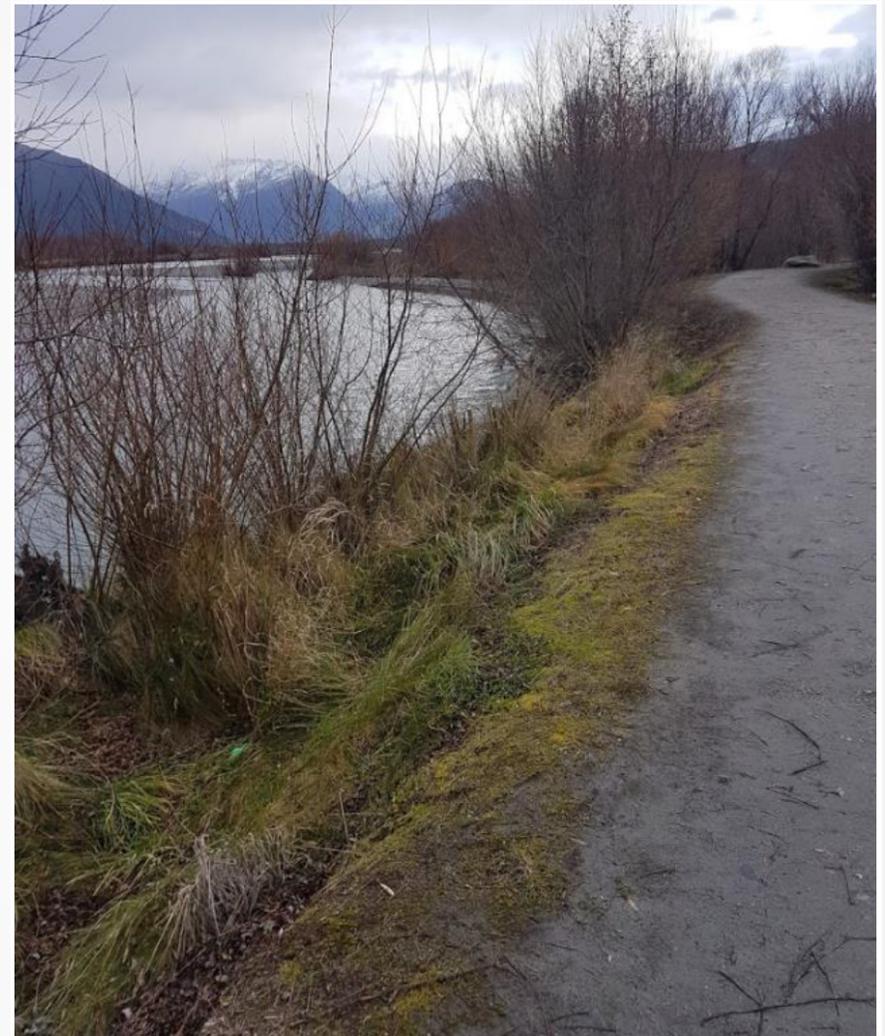
- Review of Rees River erosion and geotechnical issues at floodbank.
- Identified erosion, undermining and scarp formation on river-side of floodbank

Headscarps forming at over steep bank downstream of the Lagoon stream confluence

- Recommendations for bank protection/erosion control
- Evaluate potential for sudden floodbank failure, and possible consequences
- Recommendations for ongoing monitoring of this structure's integrity
