COMMUNITY UPDATE 14 | DECEMBER 2021 / JANUARY 2022

Kia ora koutou. This month, we are talking about a new study on the Buckler Burn alluvial fan, and updates on the two ongoing hazards studies.

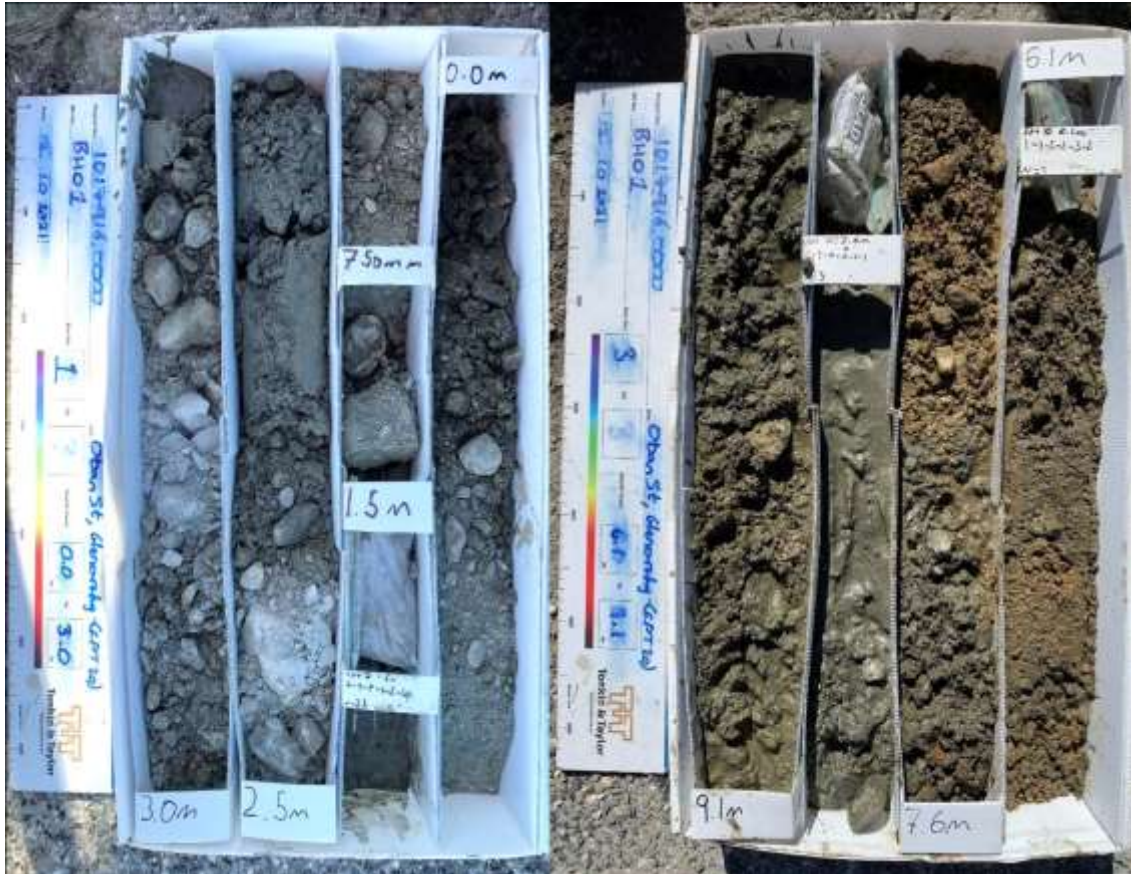
Drill core photographs showing sediments from borehole BH01, the location of this hole is shown in the aerial view of Glenorchy image below. These are examples of coarser gravels near the surface (0-3 metres depth, left), and finer sands and gravels deeper in the hole (6-9 metres depth, right).

A physical geography team from Massey University are currently investigating the natural processes that formed Buckler Burn alluvial fan. They are looking in detail at the sedimentary deposits in drill cores from the ongoing [Glenorchy liquefaction study](#) to do this. This investigation will help us better understand the potential alluvial fan hazards of the area such as flooding and debris deposition.

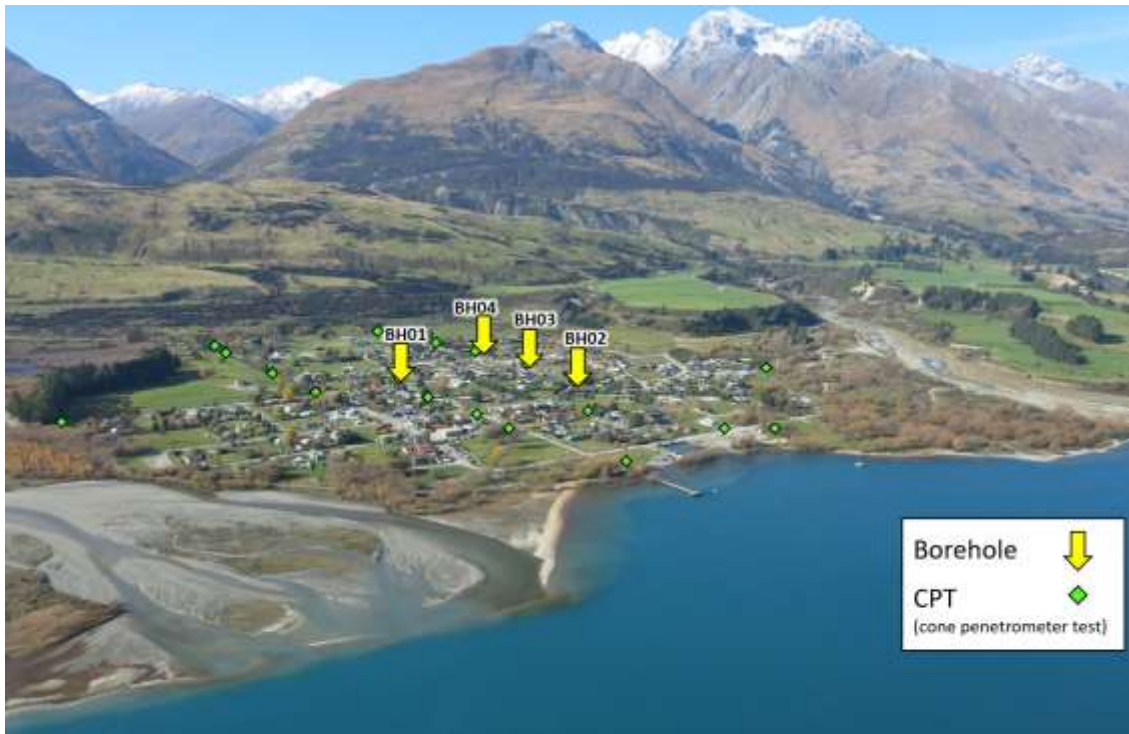
Aerial view of Glenorchy, showing the approximate locations of geotechnical boreholes and CPTs undertaken for the liquefaction susceptibility study.

Investigations and analysis from the cone penetrometer tests* (CPTs) and boreholes in Oban, Coll, Islay and Mull Streets are progressing well. We are aiming to finalise the findings to share with you all in early 2022.

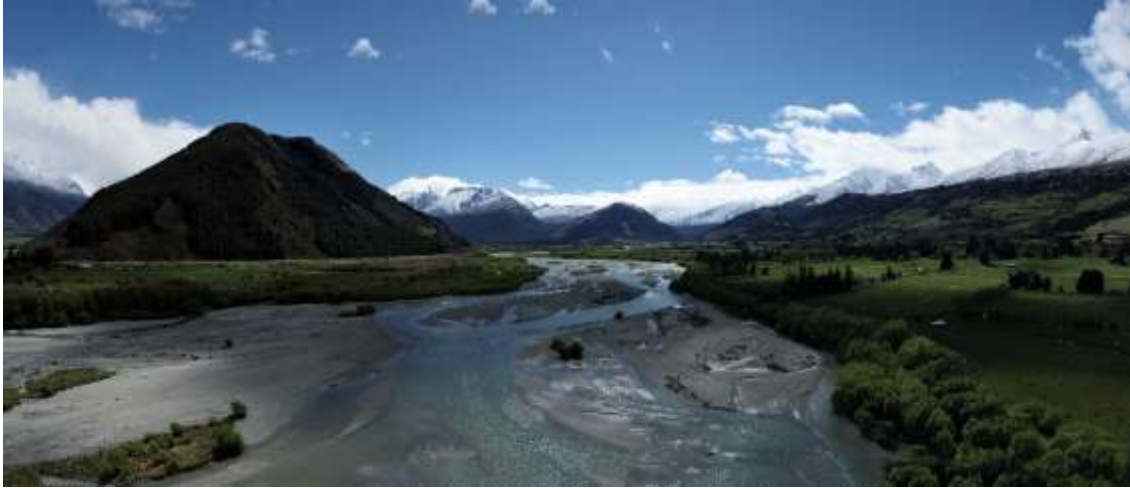
Drone image of a view upstream of Rees River, taken during our consultant's recent site visit (photo by Matt Gardner, Land River Sea Consulting Ltd).
