# ORC Update for Glenorchy Community Association

October 2019

## ORC Natural Hazards Team

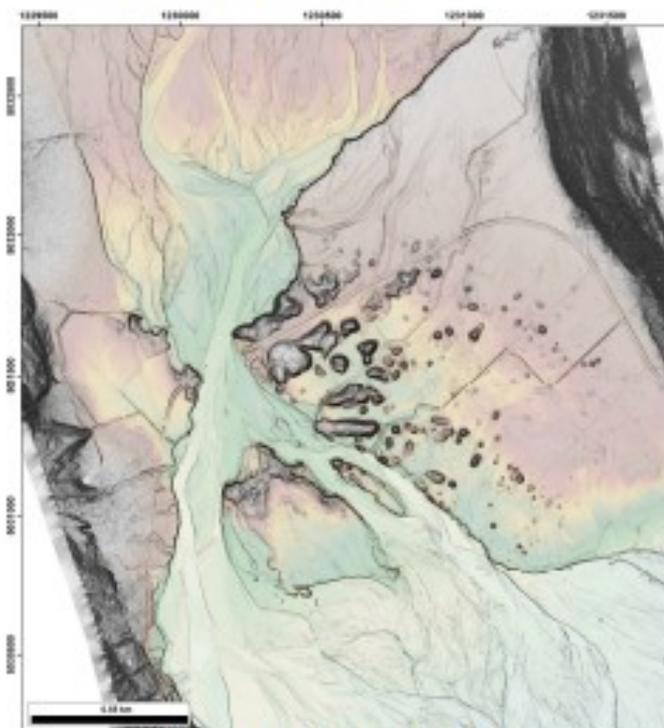
**Dart Bridge & the Hillocks**

- Detailed topographic survey

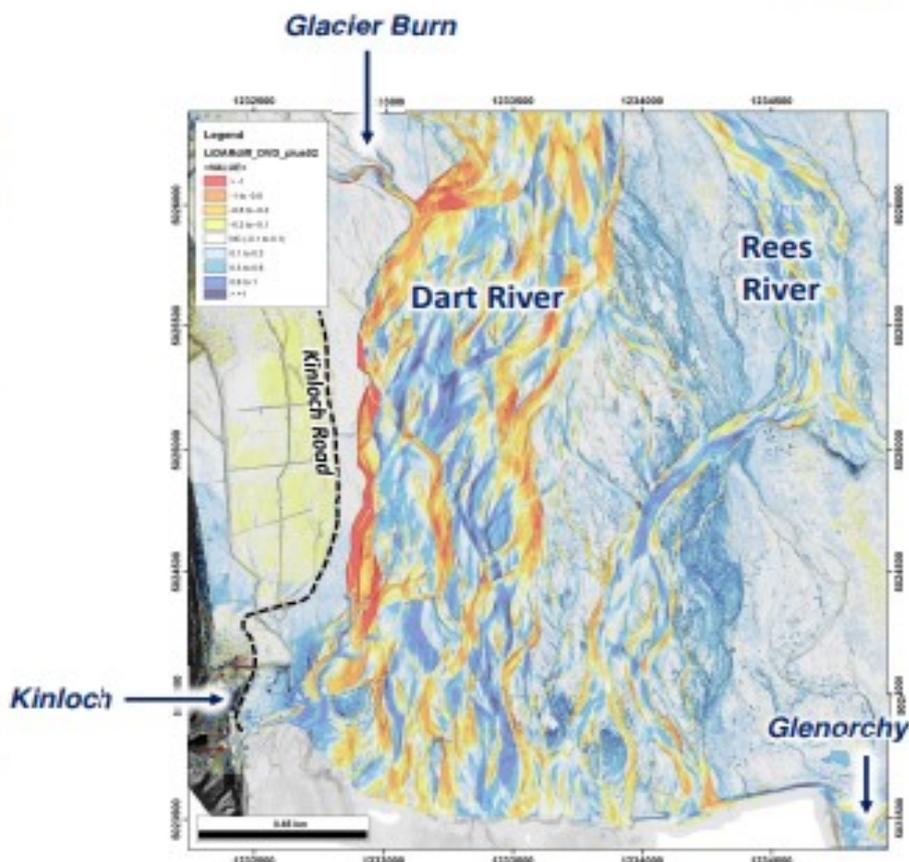
# LiDAR survey changes (2011-2019)

- Riverbed changes in detail since previous 2011 survey
- Shows westward erosion between Glacier Burn and Kinloch

**Orange and Red**  
Elevation decreases (erosion)

**Darker blue**  
Elevation increase (sediment deposition)

**Yellow and pale blue**  
Minor differences due to vegetation changes

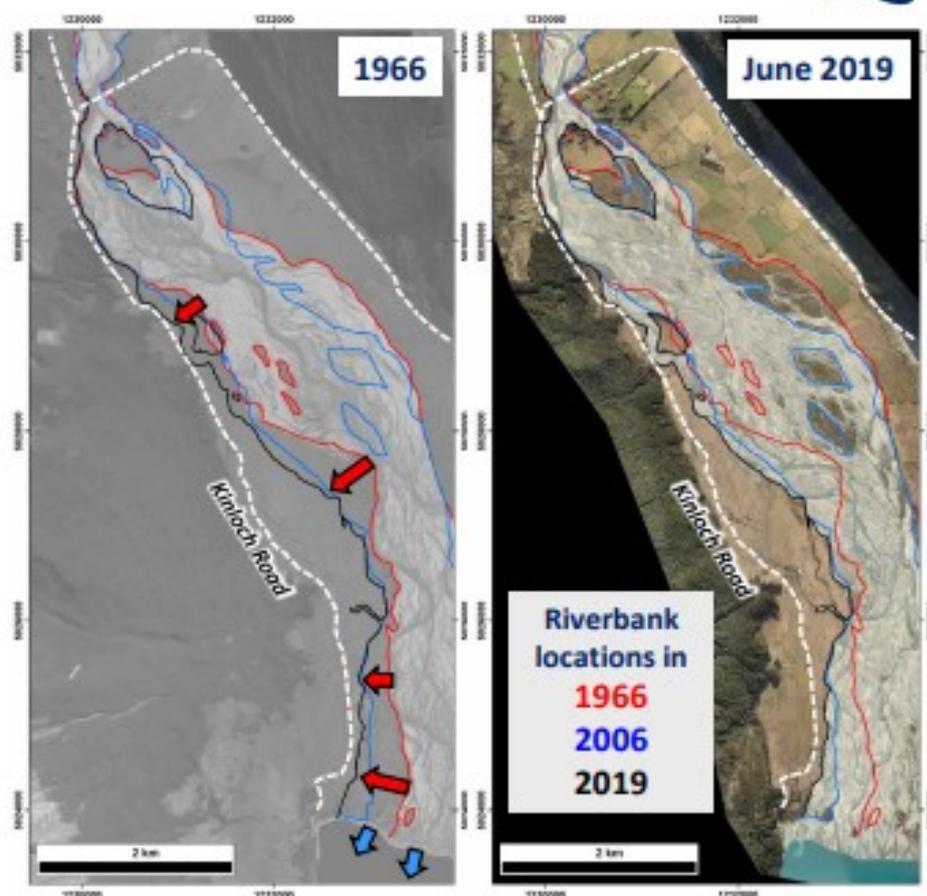
## Aerial photography

Significant change over last 50 years:

- Westward erosion
- Delta growth

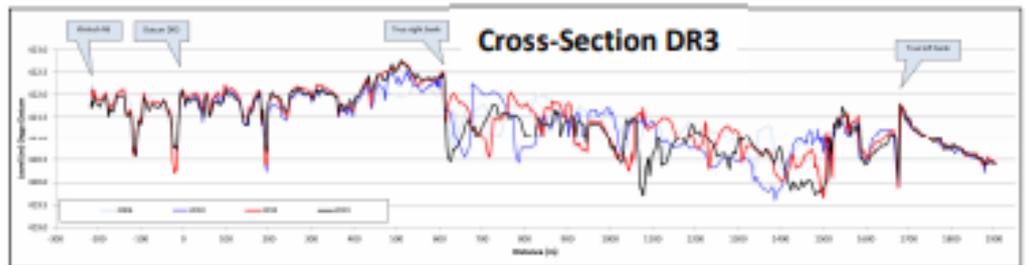
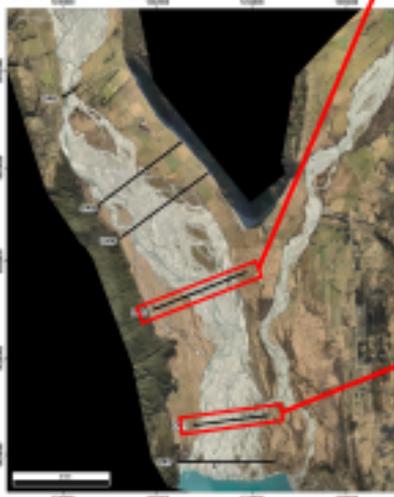
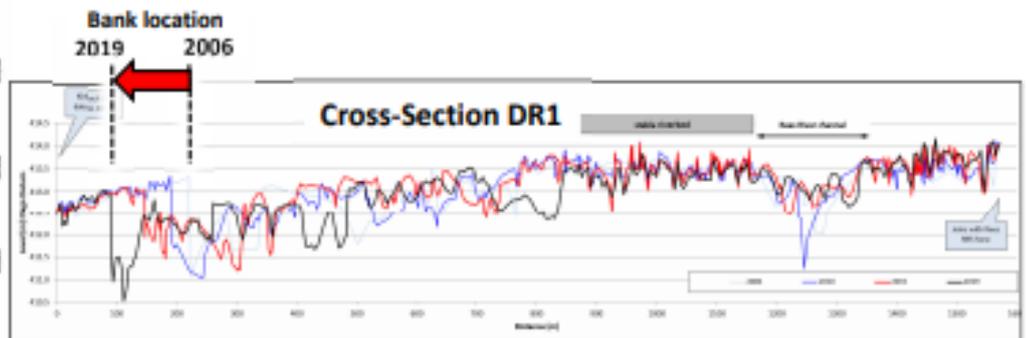
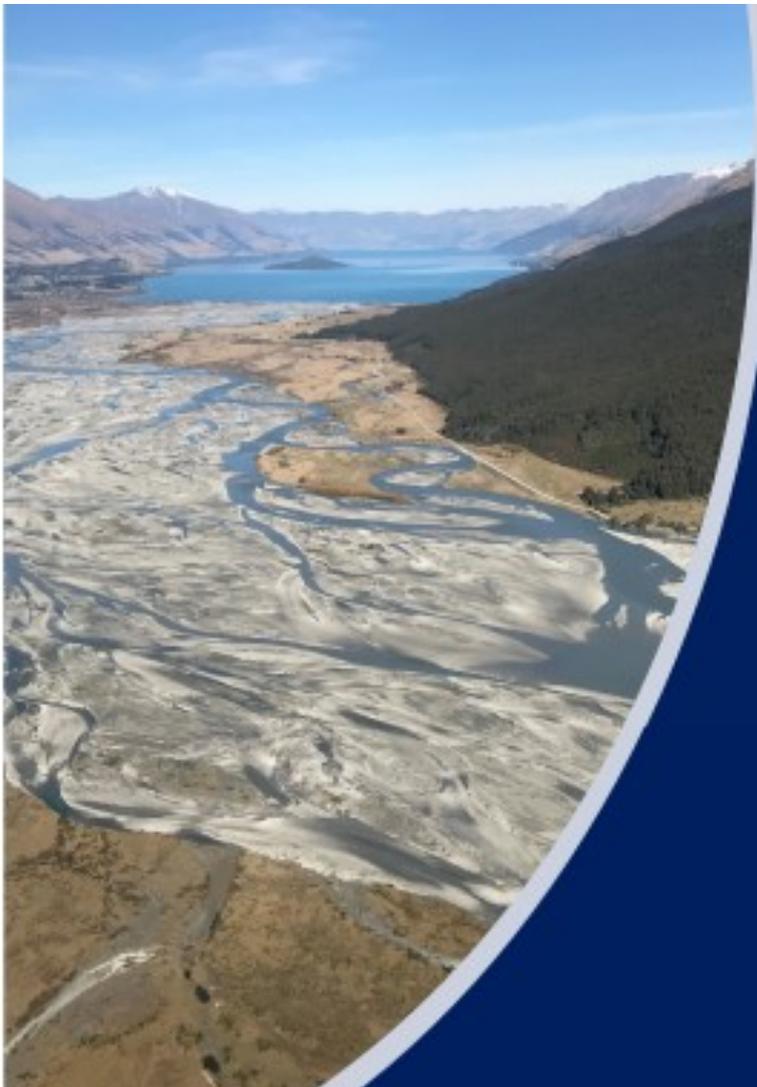
## River Channel Cross-Section surveys

- Show changes to river form
- Bank positions, location and depth of main channels

River channel in  
2006 2010 2015 2019

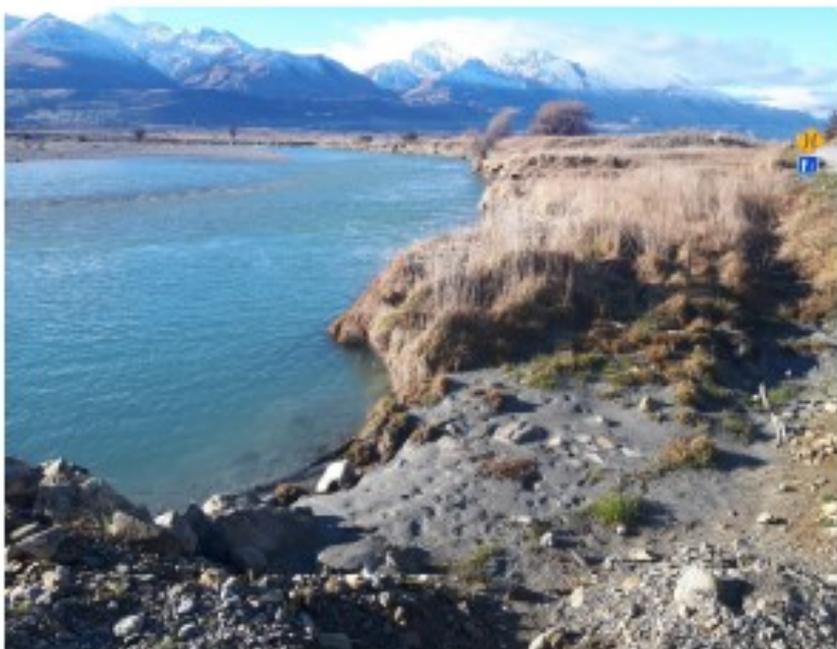
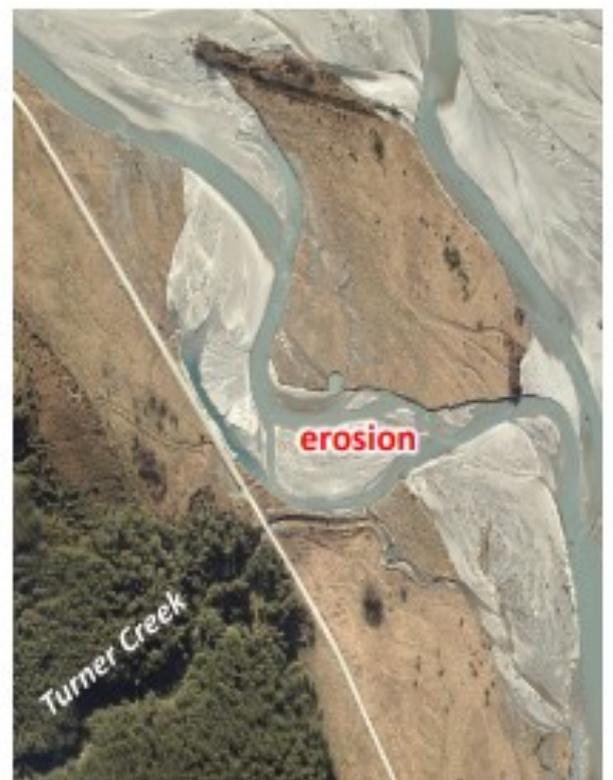
- Erosion immediately north of Turner Creek
- Highest priority – focus for short-term bank protection works

**By end of October:** Geotechnical assessment and recommendations for bank protection in the Turner Creek area.

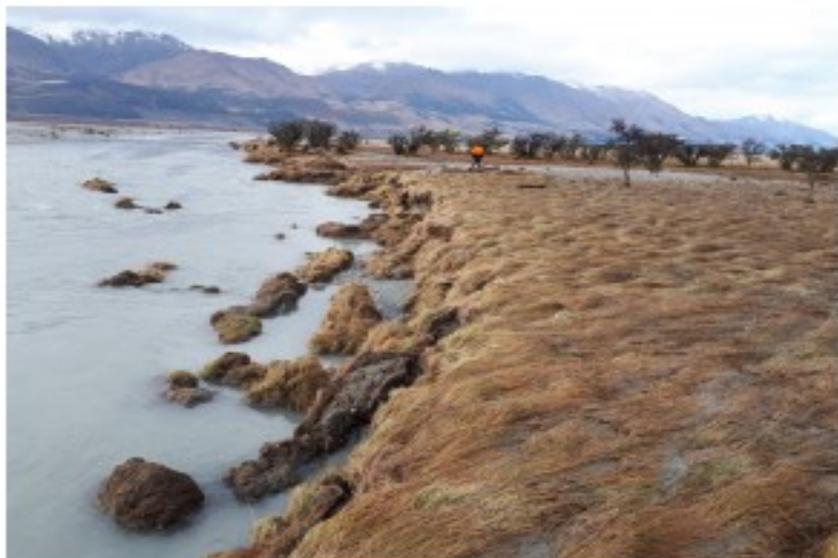
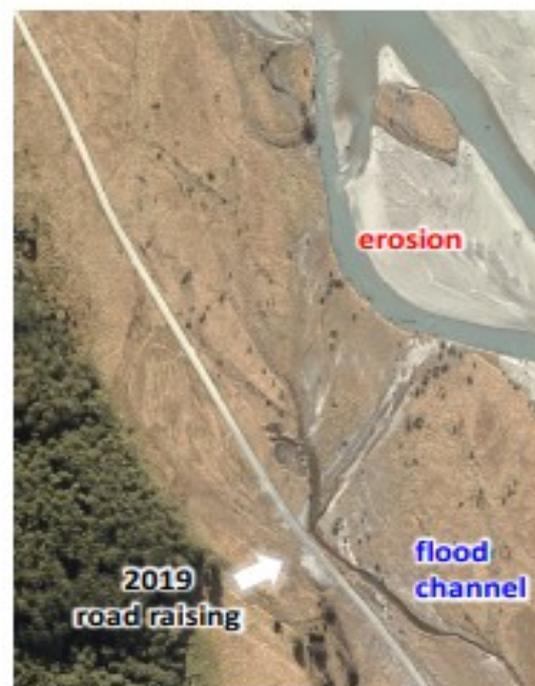
- Continuing erosion of Dart River western banks to south of Turner Creek
- High flows into old river channel next to road
- Will assess effectiveness of QLDC's road raising over coming months
