Impacts of Septic Tanks in Glenorchy

Update July 2020

Alexandra Badenhop, Principal Hydrogeologist, e3Scientific Limited
B.Eng. (Environmental)(Hons 1). M.Eng.Sci (Groundwater Studies)

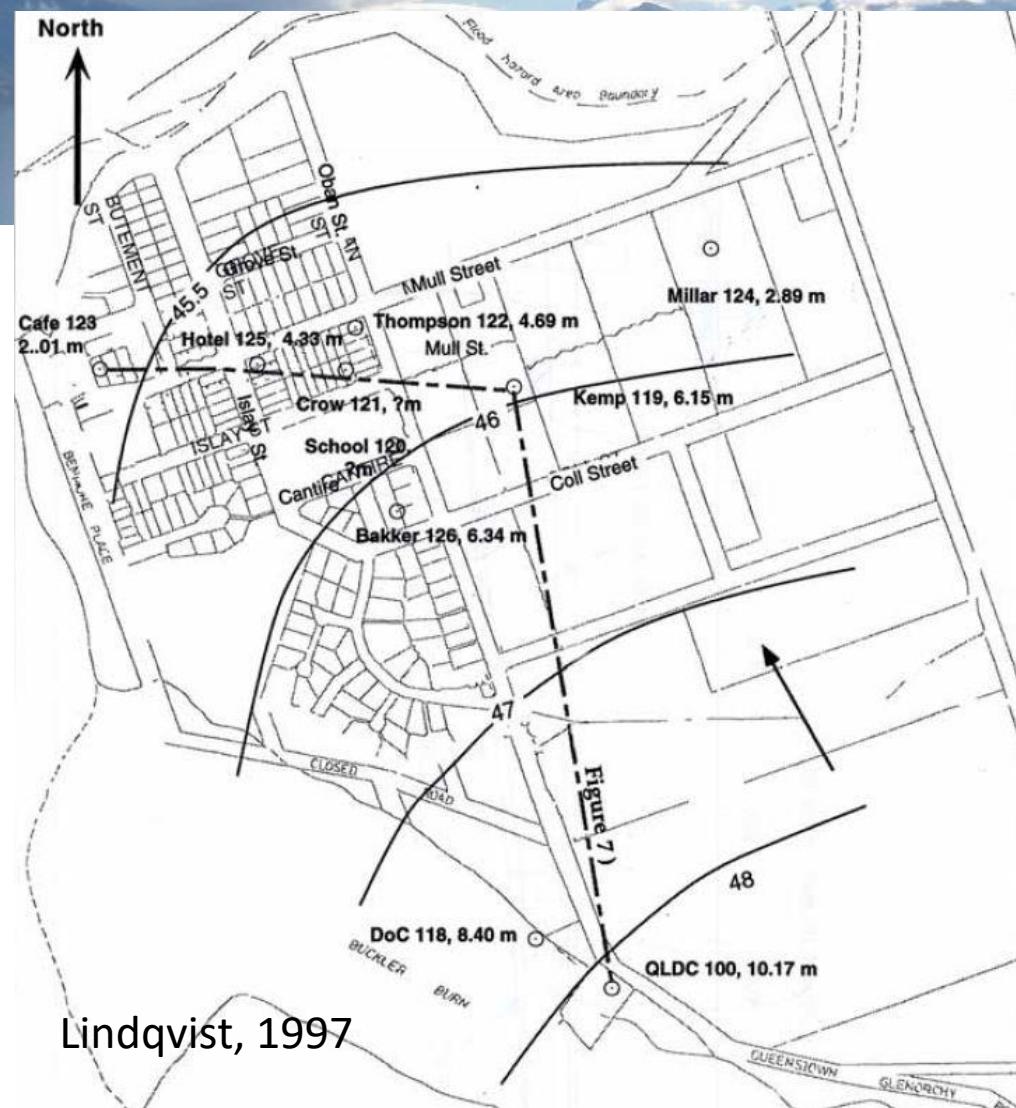
Where does it go?

- Water levels
- Surveys

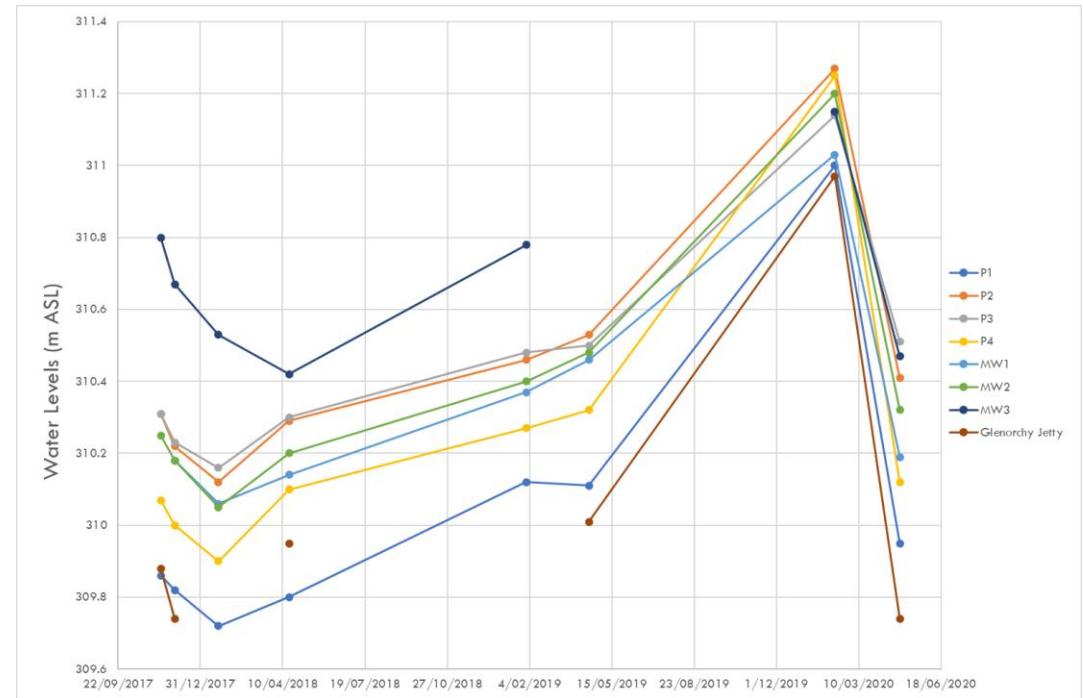
Groundwater levels

Location	Water Level (m below ground)		
	Min (Feb 2020)	Max (Jan 2018)	Median
P1	0.15	1.43	1.25
P2	2.82	3.97	3.73
P3	0.16	1.14	0.91
P4	2.75	4.10	3.89
MW1#	7.86	8.83	8.70
MW2	5.35	6.50	6.27
MW3	13.12	13.85	13.60

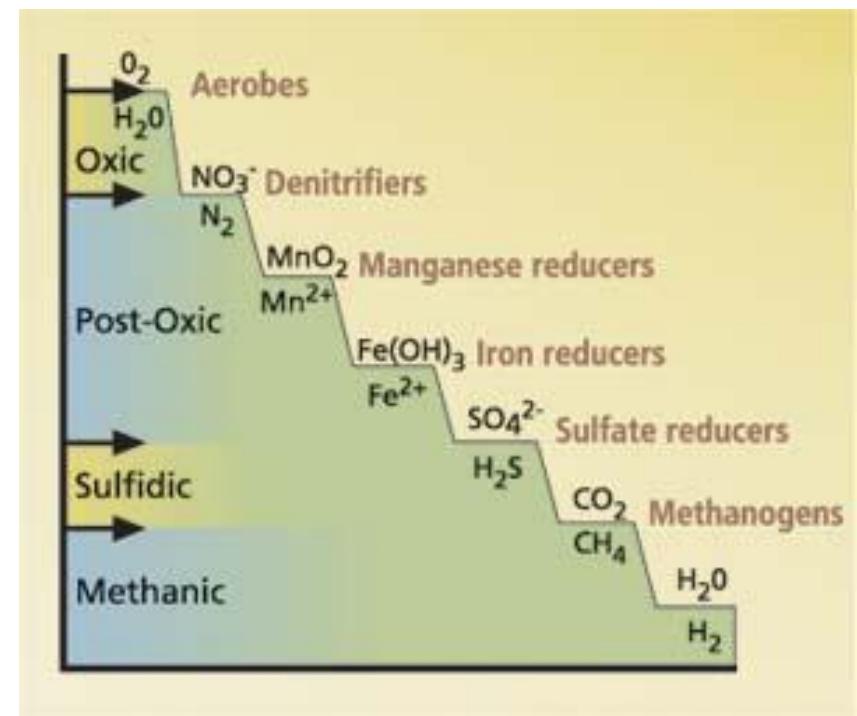
Some background chemistry - redox

- Dissolved organic matter leaching from soils can change the chemistry of the groundwater

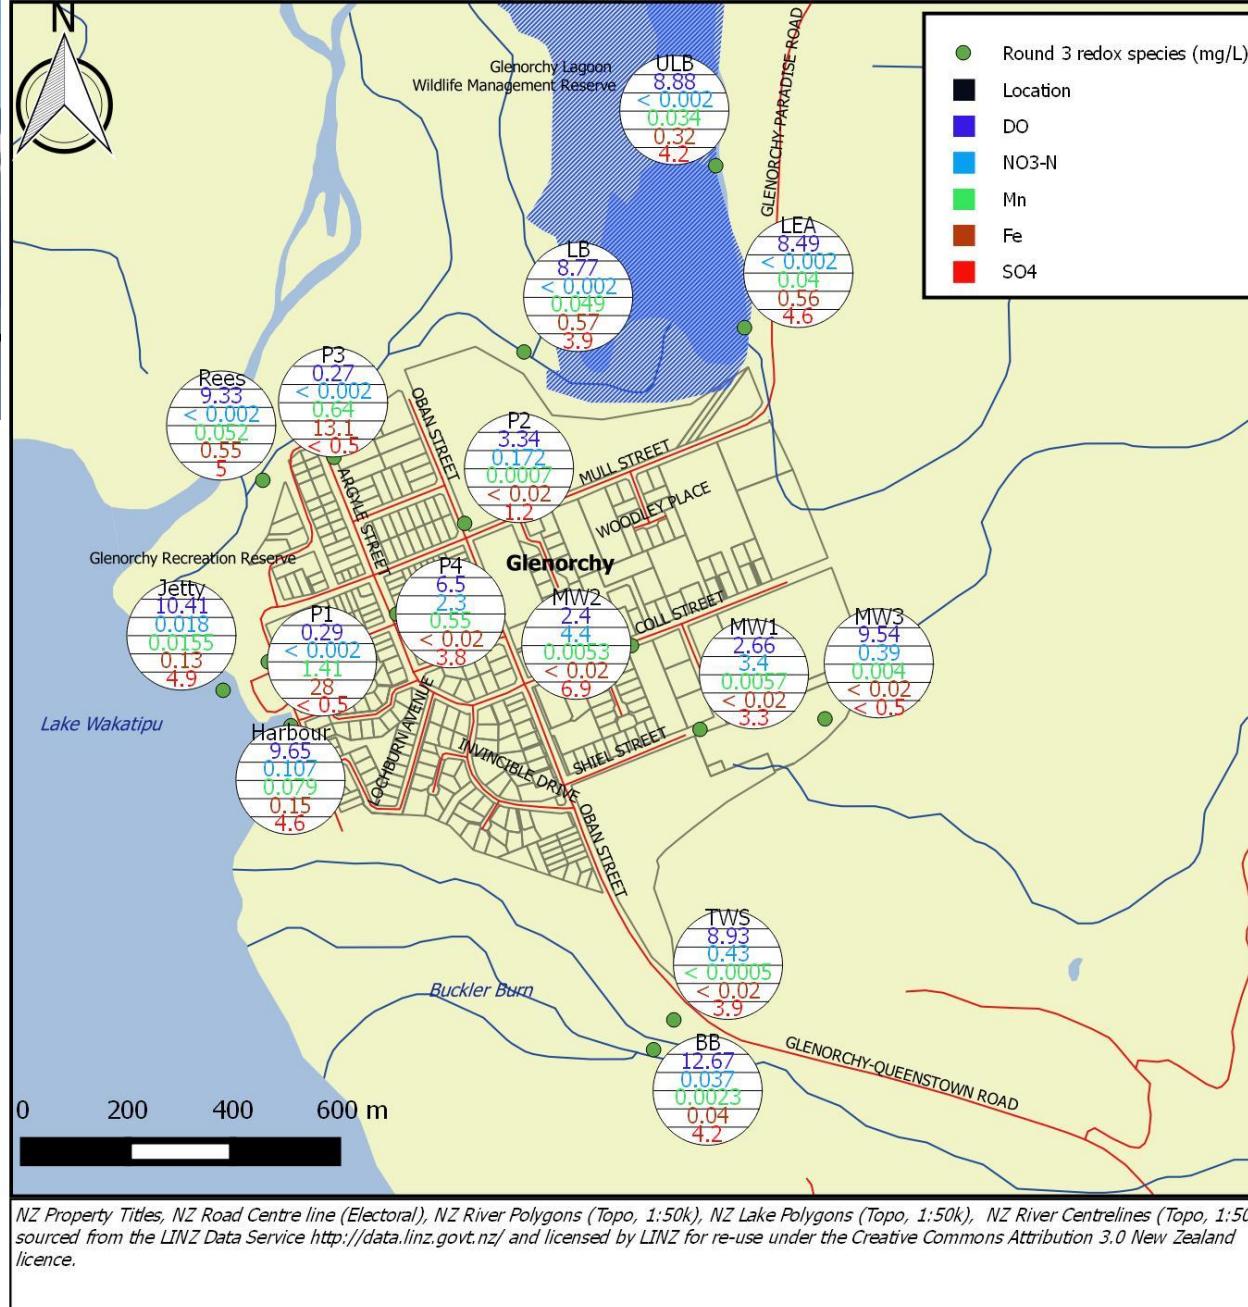
Water Quality Results

- Redox sensitive species
- Iron P1 (26.7 – 42 mg/L) and P3 (8.9 – 15.7 mg/L)
- Manganese P1 (1.22 – 1.92 mg/L)

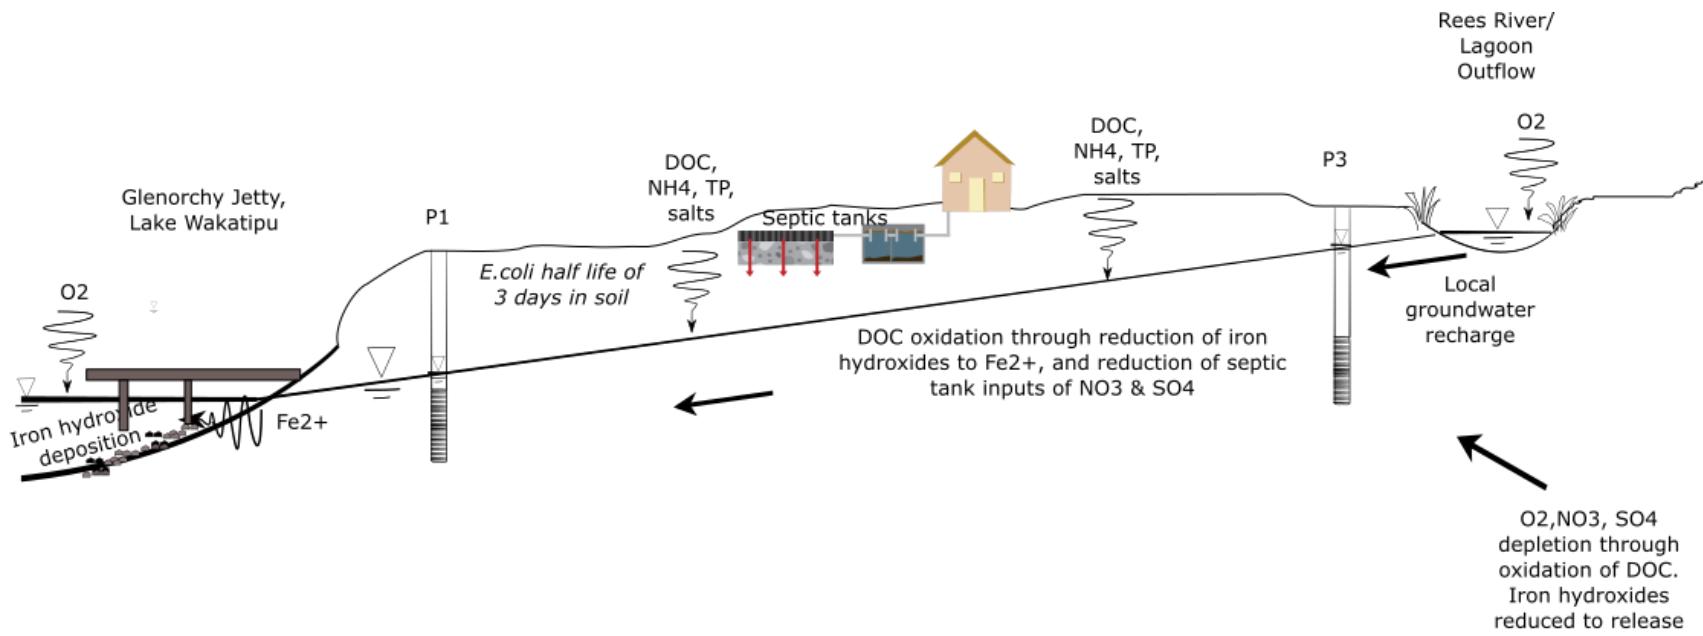
Iron Deposition

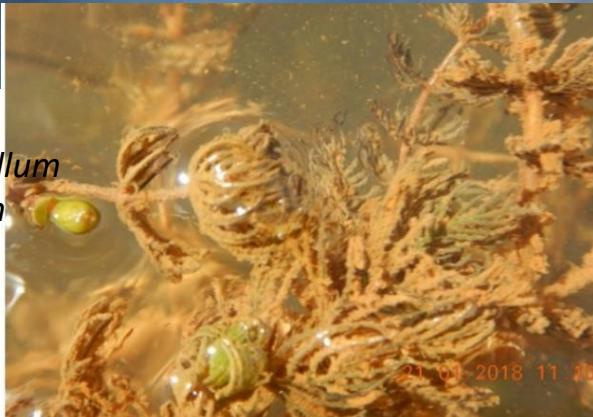
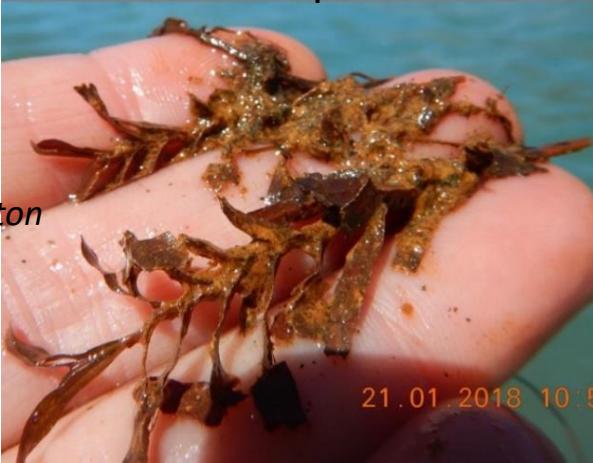
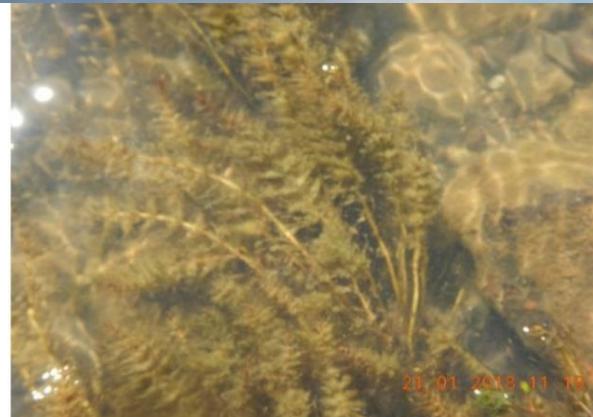
Iron Deposition Ecological Effects

Myriophyllum triphyllum

Inside iron deposition area

Potamogeton crispus

Outside iron deposition area

- Only one type of snail
- No large adult fish

Location	Hydrology	Water Quality	Ecology
Glenorchy Harbour	Receives groundwater discharge poorly mixed	Total Nitrogen, NH ₄ -N and E.coli. > ORC (2016) Schedule 15 good water quality targets for Lake Wakatipu Manganese and iron concentrations elevated.	Seasonal surface water quality degradation within the harbour May be declining annually. So far nutrient levels healthy macrophyte growth and diversity
Glenorchy Jetty	Receives groundwater discharge well mixed	Iron deposition, phosphorous increasing (may bind to iron)	Macroinvertebrates diversity and abundance is decreased Longevity of benthic dwelling fish may be limited in this area. Macrophyte communities suffered morphological iron toxicity symptoms.

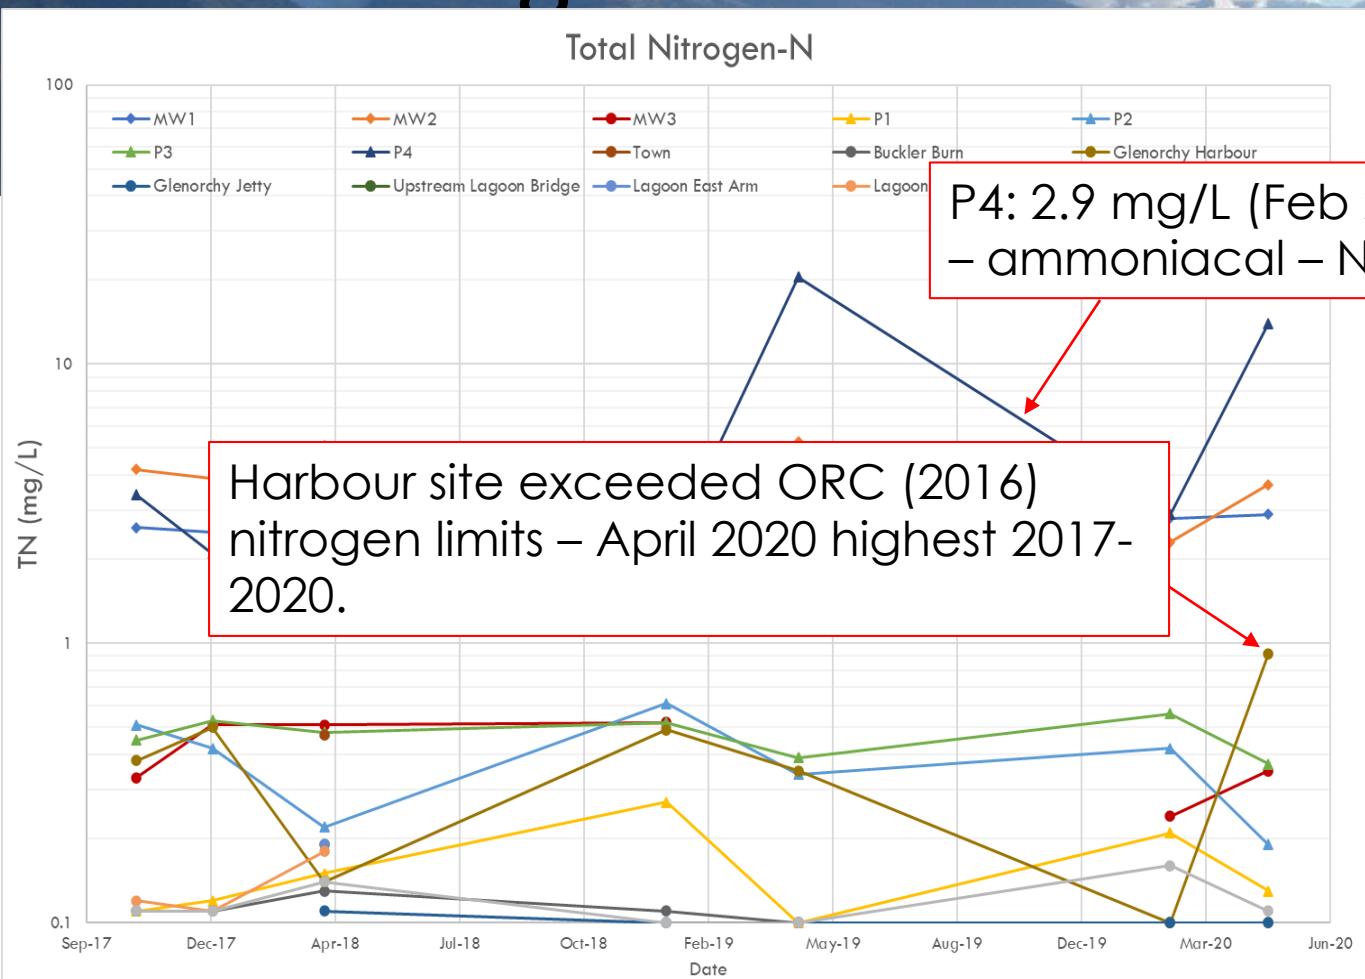
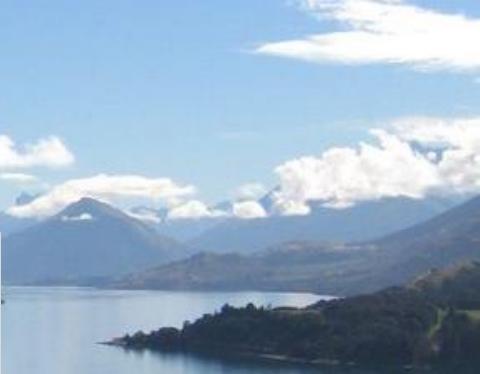
Nitrogen

Total Nitrogen-N

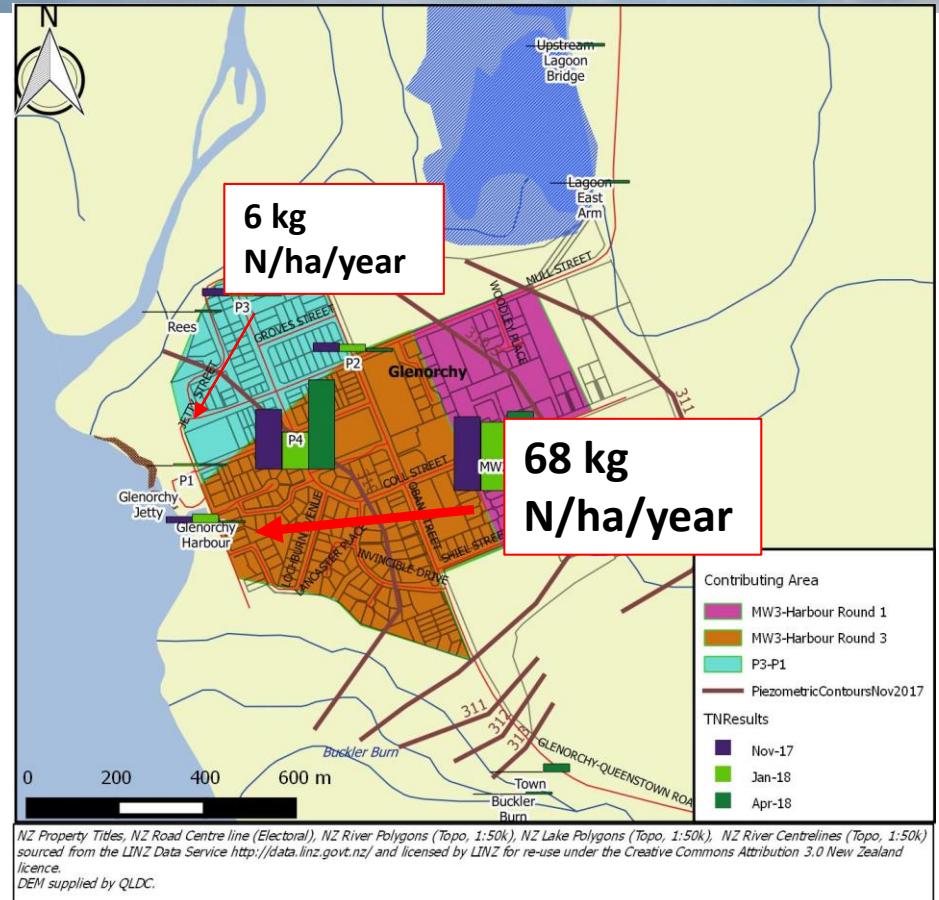
Nitrogen Loadings

- Otago Regional Council: areas where nitrogen loading exceeds 30 kg/ha/year = high priority for change.

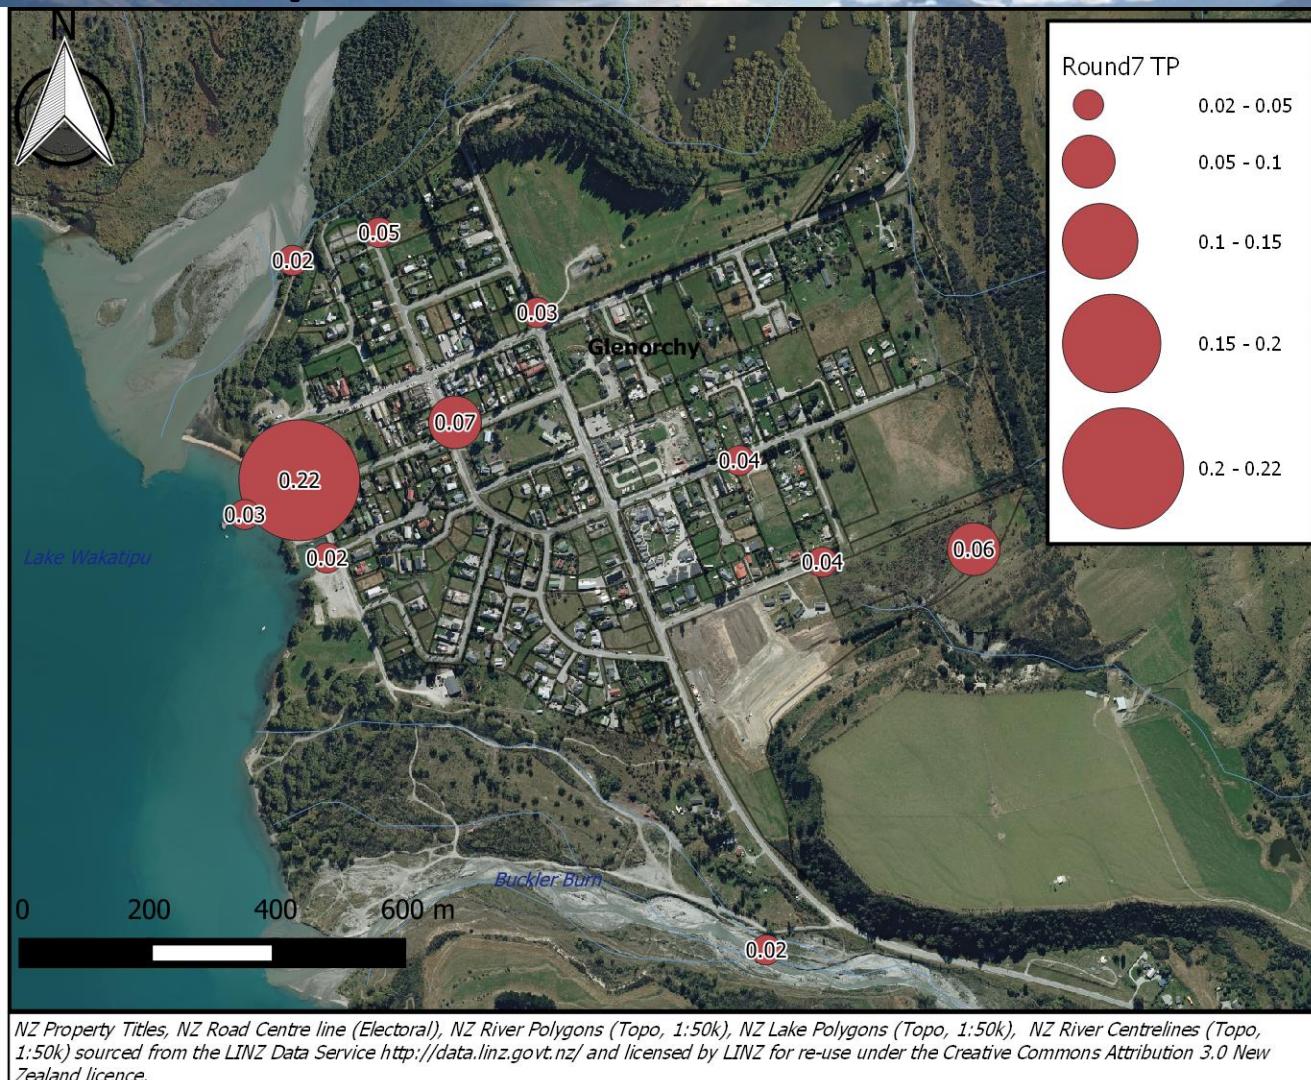
Phosphorous

- DRP in P1, P3, and P4, exceeded ORC (2016) Schedule 15 limits for tributaries entering Lake Wakatipu.
- Oligotrophic bracket (0.004 – 0.01 mg/L).
