# Glenorchy Rees Floodbank

## Floodbank Assessment

3 September 2020

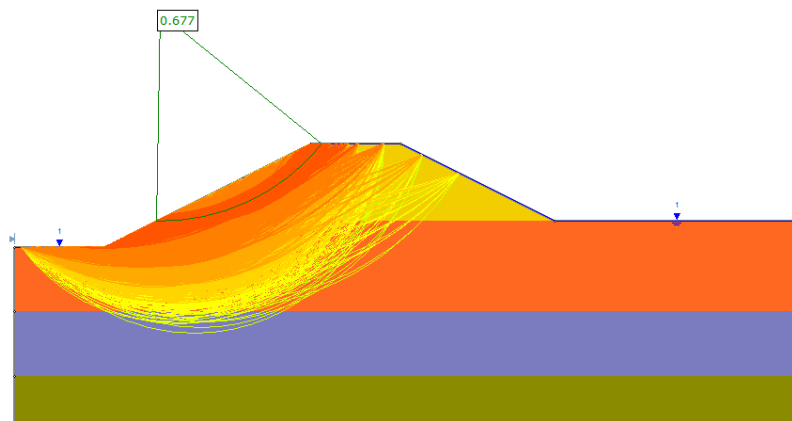
Figure 3 - Example slope stability assessment output

An example input to the modelling is provided below, and an example output, showing a factor of safety of FOS 0.6, is presented in Figure 3. A diagrammatic representation of slope failure is shown in Figure 4.

Cells in red indicate those areas where the Factor of Safety is below that recommended, and indicate that a risk of failure may be present. The text in bold indicates a Factor of Safety less than 1.0, suggesting the stopbank would be unstable and prone to localised failures.

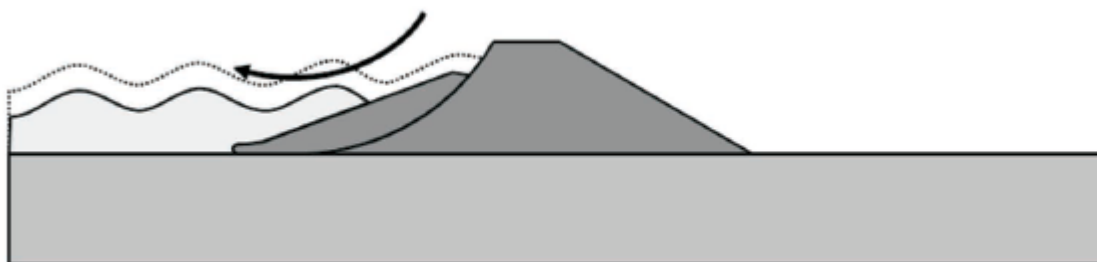
Figure 4 - Diagrammatic representation of rotational slope failure (from CIRIA C731)

Slope instability typically occurs when the strength of the bonds between the soil particles forming the stopbank are exceeded, causing them to move, slide or slump and ultimately fail.

Soil slopes or embankments typically fail when they lose strength, such as through increased water content, or through additional loading, or through scour and loss of support of the toe of the embankment.

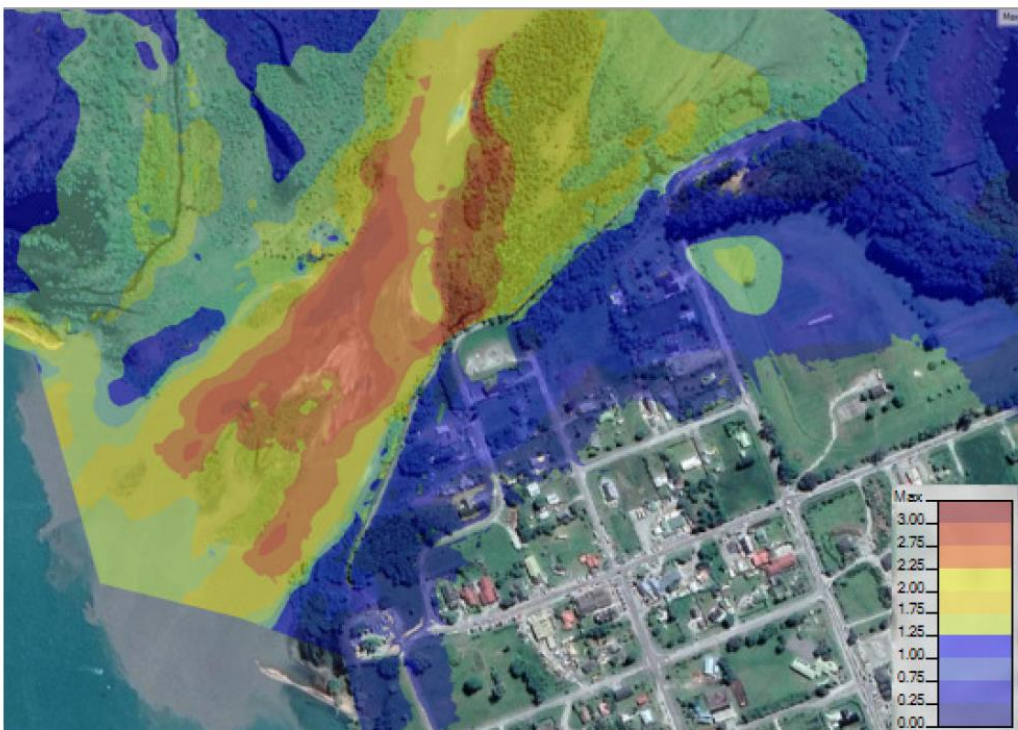
*Figure 5 - Extract from ORC memo showing velocity distribution expected.*

For the purposes of design, the ORC memo recommends a water velocity of 2.3m/s be adopted.

The water levels in the river have not been assessed as part of this assessment, but it can be seen from the modelling undertaken by ORC (Figure 5) that the extent of the flood bank should be reviewed to ensure that the floodbank is not 'outflanked' by the overflow from the Lagoons. In the scenario shown in Figure 5, the flood bank is shown to have water on each side and is therefore performing as intended.

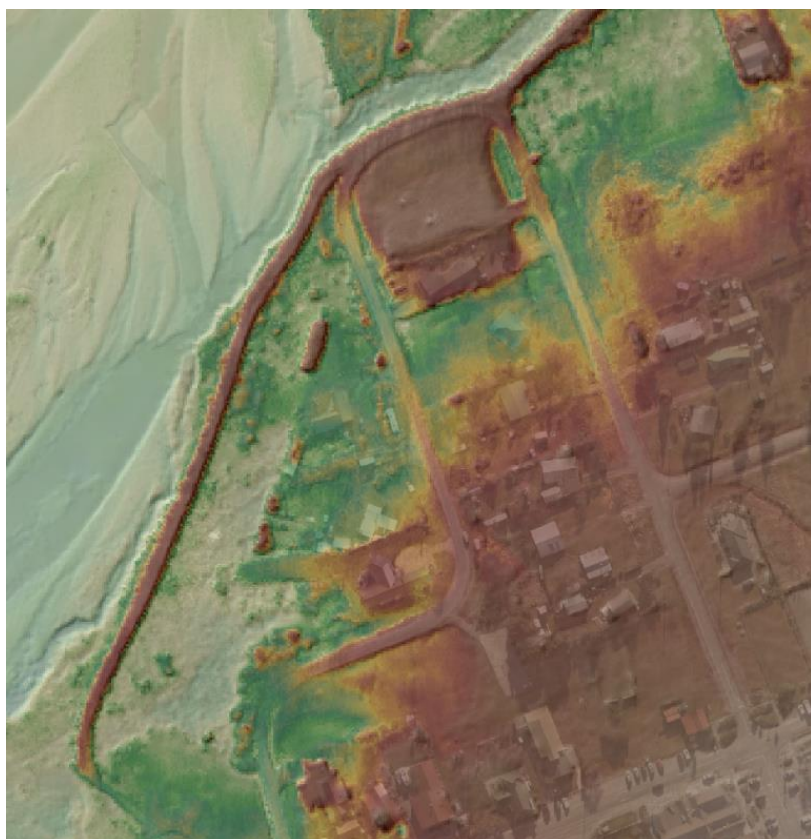
Figure 6 – Extract from Lidar, showing low lying properties

If any part of the stopbank is breached or outflanked then it is expected that the lower lying properties would be affected. Based on the Lidar information, the buildings at 14 and 18 Butement Street and 53 Argle Street would appear to be affected in such a scenario.
