# **Glenorchy flooding**

## **Update for GCA, 2<sup>nd</sup> July 2020**

# HEAD OF LAKE WAKATIPU HAZARDS STRATEGY

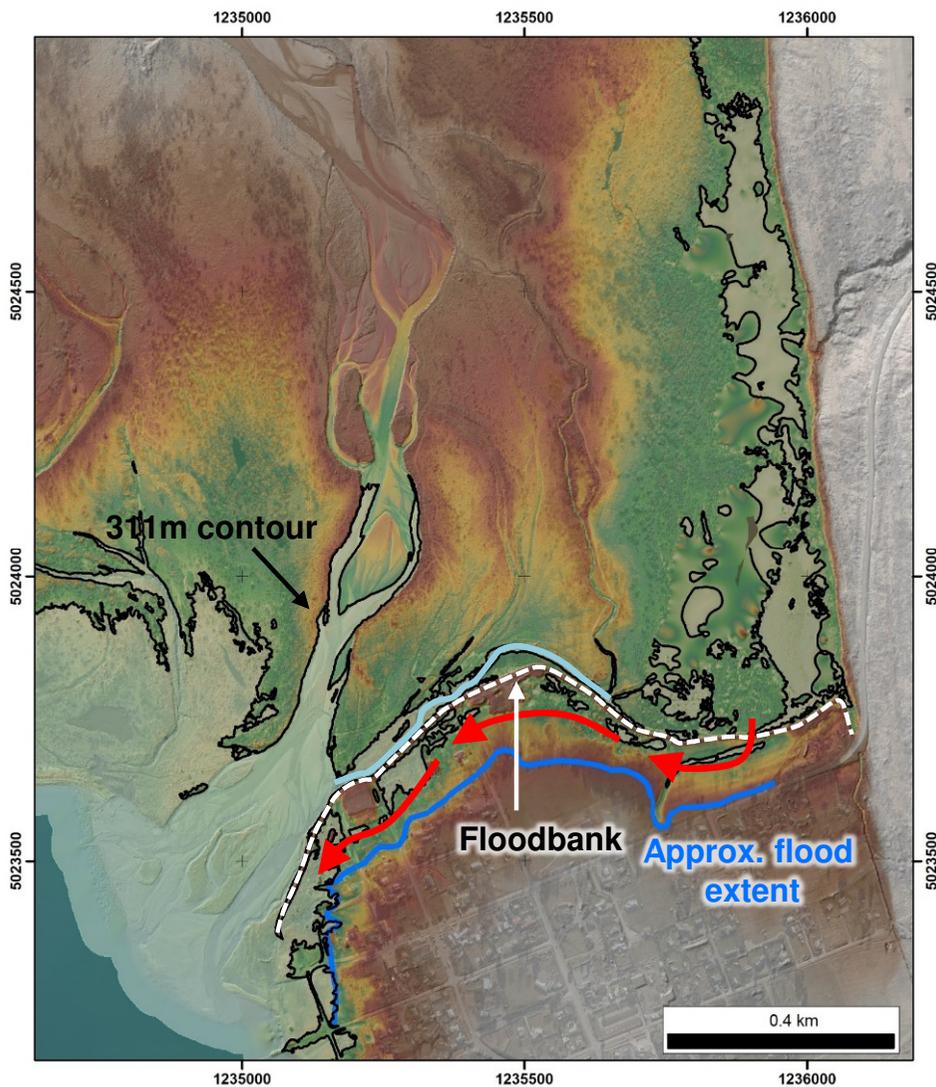
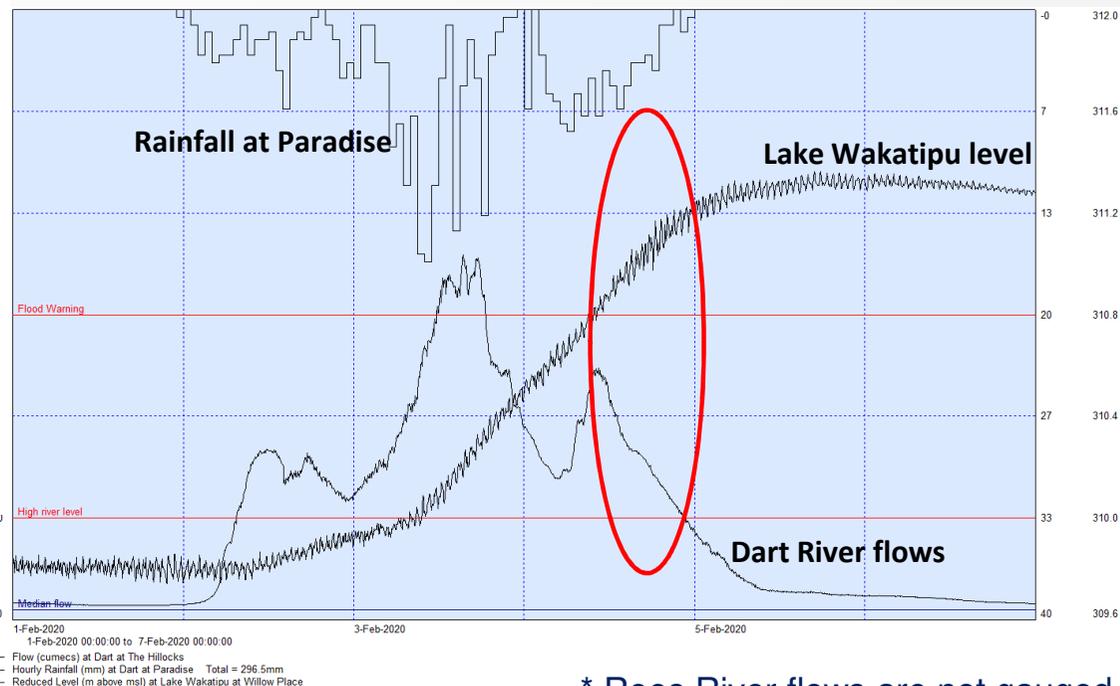
1. Widespread, heavy rainfall
  - ~300 mm total at Paradise
  - (Nov 1999 was 341 mm at Hillocks)
2. High, sustained, river flows
  - Dart to ~1800 cumecs\*, equal highest since 1996
3. Feb 4<sup>th</sup> flow peak coinciding with elevated lake levels
  - backwater effect on river flow

\* Rees River flows are not gauged
